Investigation Report

CX003-0/05
April 2006

Type of occurrence: Accident
Date: 2 June 2005
Location: Frankfurt-Sindlingen
Aircraft: Hot-air Airship
Manufacturer / Type: Lindstrand / LBL HS 110
Injuries to persons: No injuries
Damage: Aircraft severely damaged
Other damage: None
Information Source: Investigation by BFU

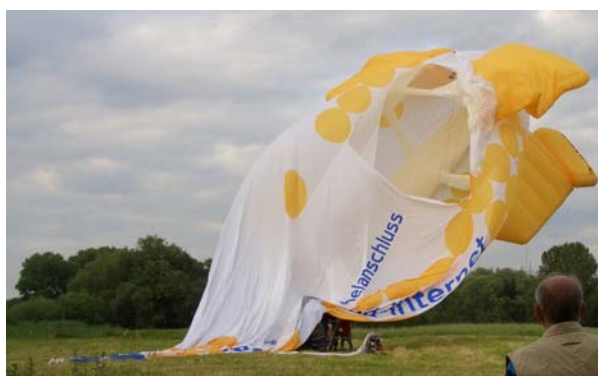
The envelope had burst open vertically and horizontally on the left-hand side in the area of the empennage involving several panels. In addition the internal left ventilation hose was torn open. A large triangular opening had formed at the tail of the airship and within a short time volume and buoyancy

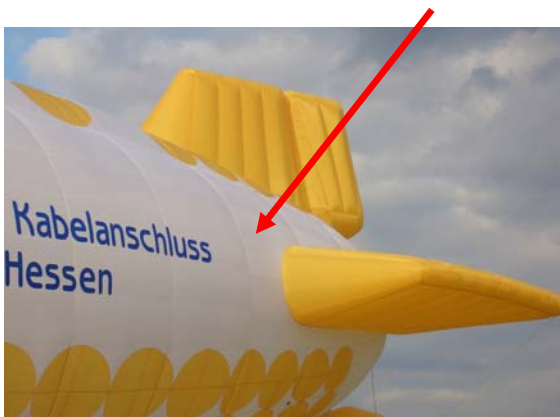
In the area of the left-hand empennage, the envelope had been torn open vertically over seven panels and horizontally over two panels.

The vertical rip involving seven panels was located in the section in which the left-hand fin was incorporated. The horizontal rip was above the left-hand fin. Both rips ran along the load tapes. The seams themselves were intact.

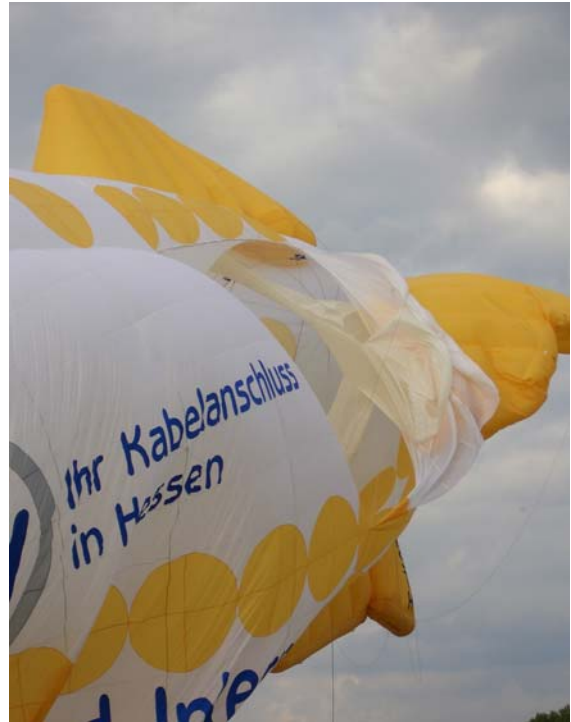
The ventilation hose was torn open along the seam to the left-hand fin over a length of more than 2 meters.

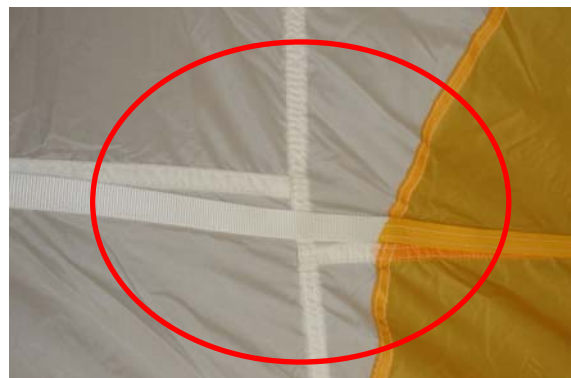
The overall sewing of the envelope material showed distinct deficiencies.

The ends of several horizontally sewn panels did not match precisely.

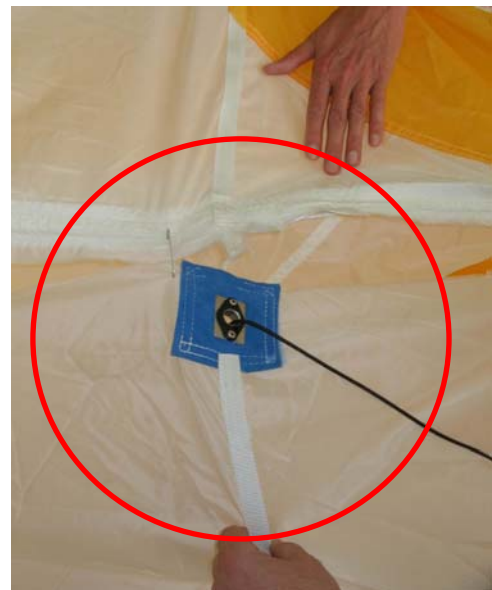
Investigation of the airship envelope showed that the rip in the envelope started in the area of the eyelet for control line for the left-hand control cable.

Because the envelope expanded due to the internal pressure but the load tape running around the envelope did not a very high tensile stress occurred in the area of the eyelets of the discontinuous circumferential load tapes and this caused the fabric to tear. On other eyelets, the fabric showed clear signs of high tensile stress in the run-up to tearing.

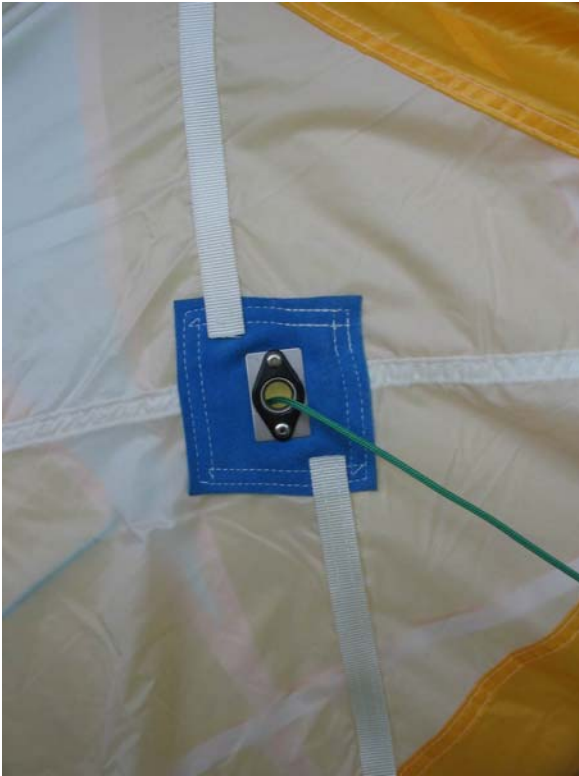
The actual positions of the eyelets in the load tape were less than optimal in view of the loads which occur in service. The load tape did not form a closed loop around the envelope but had gaps at each of the four eyelets for control lines.
