Investigation Report

CX003-0/05
April 2006

Type of occurrence: Accident
Date: 2 June 2005
Location: Frankfurt-Sindlingen
Aircraft: Hot-air Airship
Manufacturer / Type: Lindstrand / LBL HS 110
Injuries to persons: No injuries
Damage: Aircraft severely damaged
Other damage: None
Information Source: Investigation by BFU

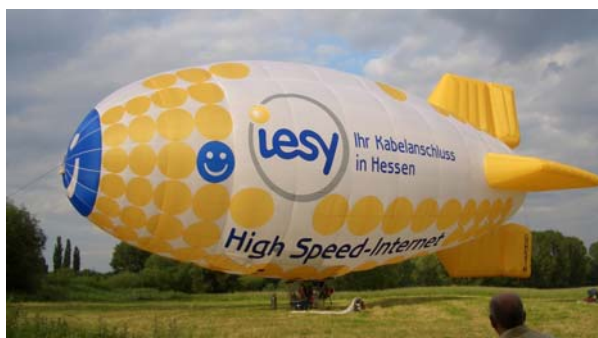
During this check the burner was activated several times for short periods to keep the envelope warm and a cold-air ventilator was used to maintain the required envelope pressure. When the Rotax engine had been started and the airship was ready for lift-off, there was a bang. The airship pilot felt a heavy push in the gondola and noticed that the envelope pressure had dropped considerably.
